Channel Stability Problems, Iao Stream, Maui, Hawaii

**U.S. Army Engineer Committee on Channel Stabilization
Report of the 64th Meeting—September 1999**

ERDC/CHL SR-00-2
CCS-00-2
June 2000

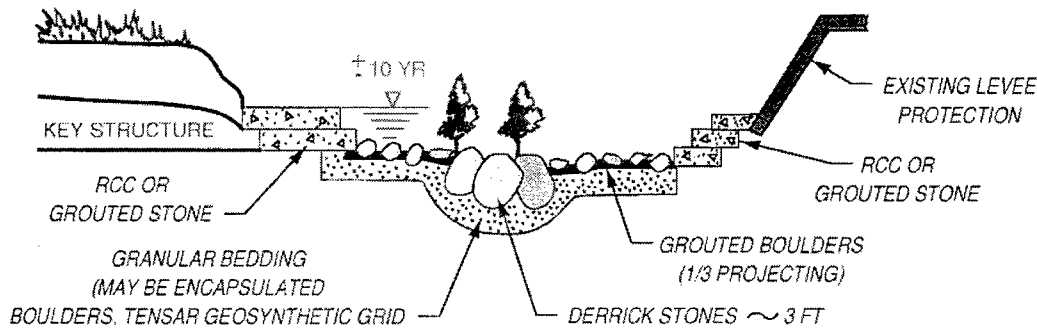
Figure 1. Cross section of armored channel adjacent to existing levee

Key structures would prevent flanking at high flood flows. Cross channel grade control sills should also be included as a safety feature. Keys and grade control should be spaced between 200 to 500 ft.

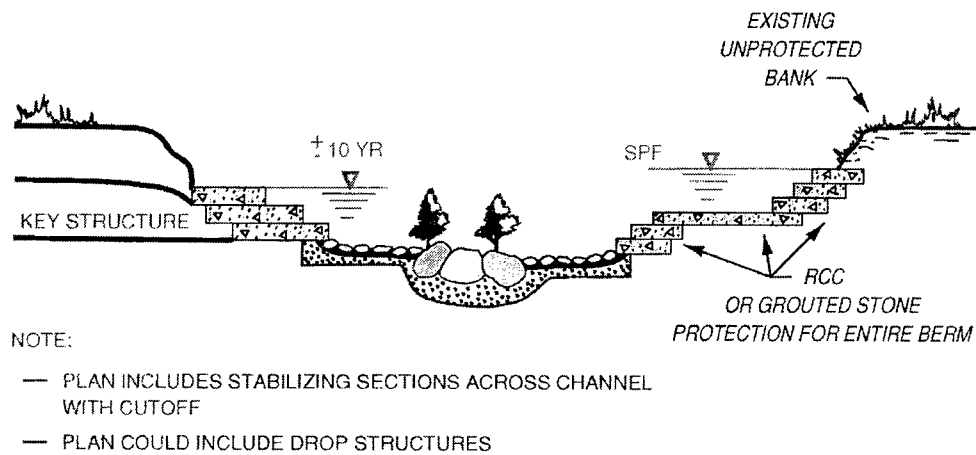
Figure 2. Cross section of armored channel adjacent to unprotected bank

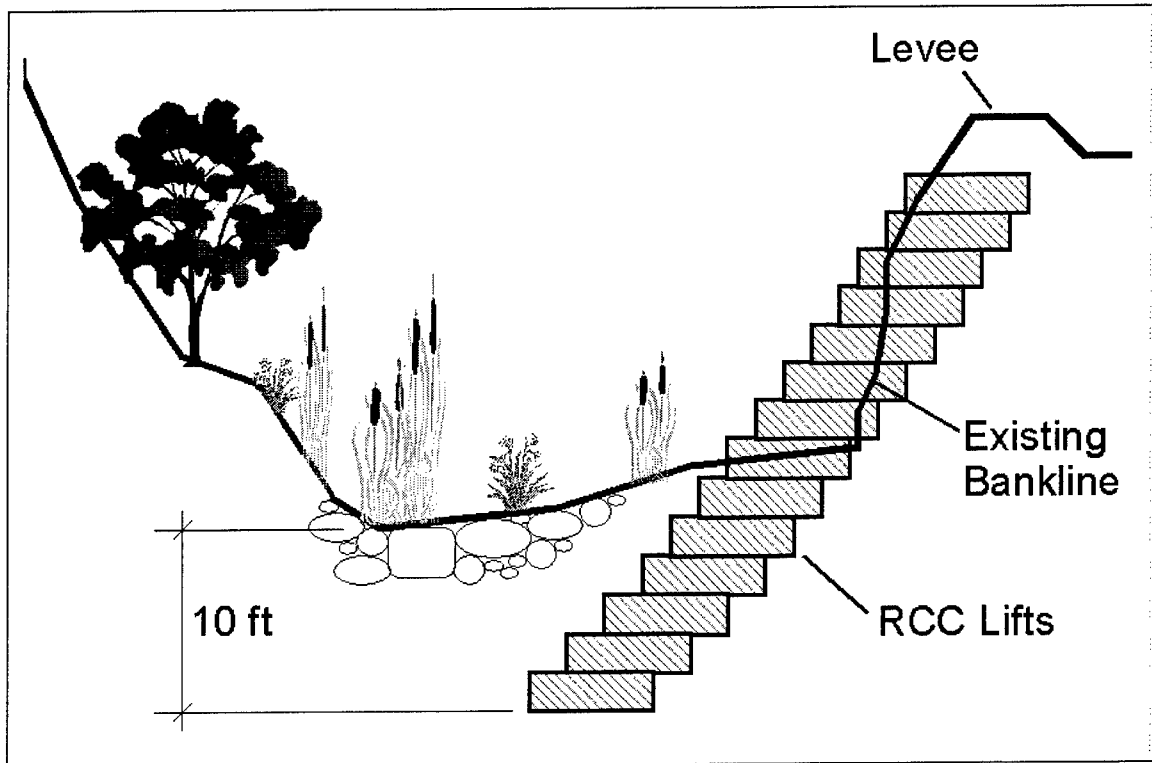
Bank protection at Sta 43+00. During the field trip, one of the more spectacular sights included the eroding bank near Sta 43+00. It appears that the sideslope of the right levee (Levee B) has eroded by as much as about 15 to 20 ft (or more) horizontally. I would recommend that POH give this reach top priority since failure of the levee is imminent. I envision that the roller-compacted concrete (RCC) sideslope discussed for the channel alternative be constructed along the right bank as soon as possible along this critical reach (Figure 7). Future construction of the channel could be designed to tie into this "early-built" section as necessary. Perhaps, the RCC sideslope could be constructed a minimum of 10 ft below the existing thalweg to prevent undermining, at least for the next few years, while at the same time providing immediate bank protection along this reach. I recommend EM 1110-2-2006 "Roller-compacted concrete" (1992) as a reference for RCC design and placement.

Figure 8. Bank protection alternative near Sta 43+00

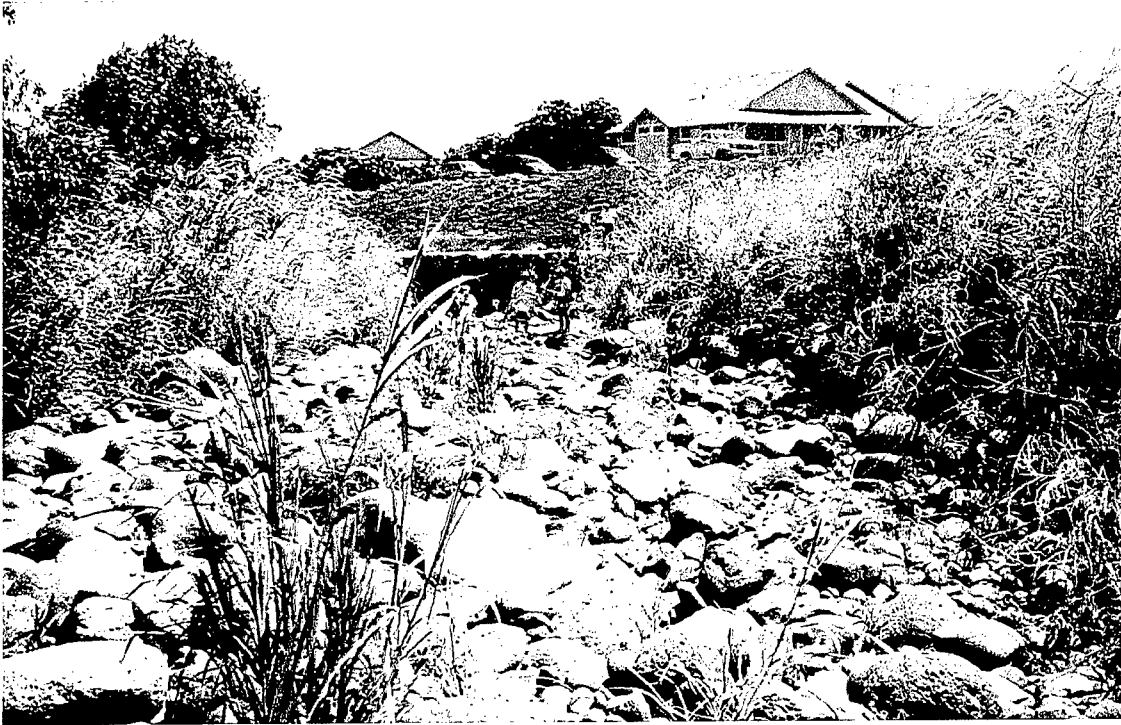
Photo 3. Channel impingement at Sta 50+00

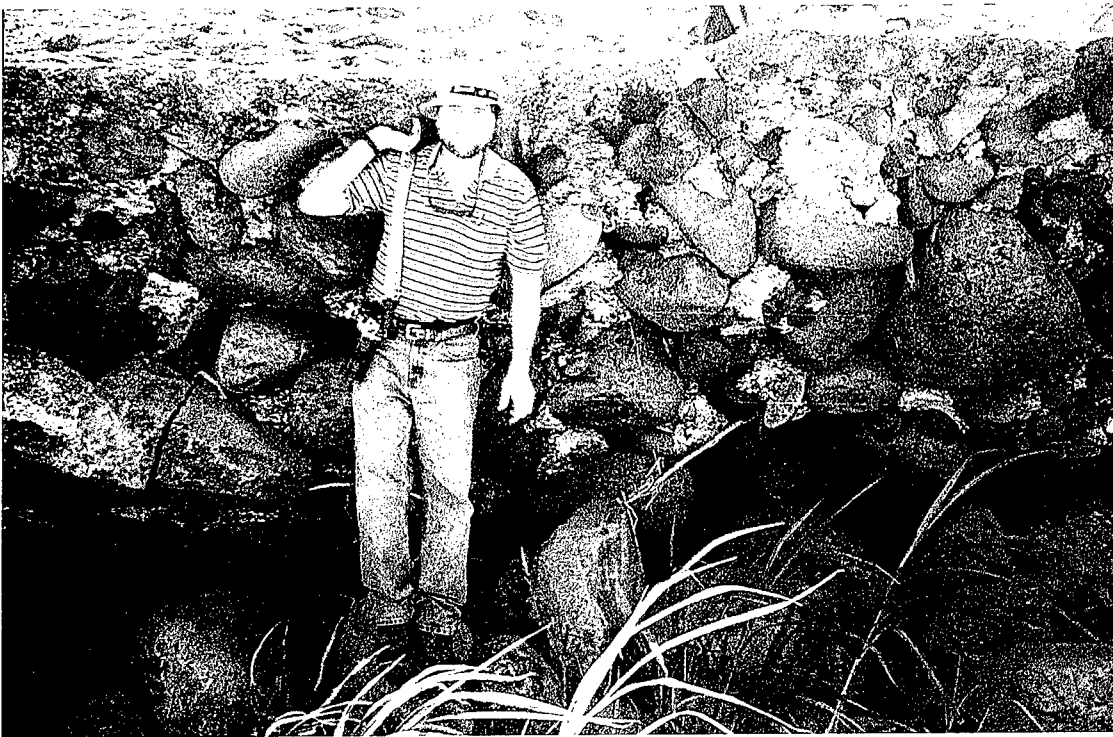
Photo 4. Local scour under grouted stone apron Sta 41+00 to 49+00

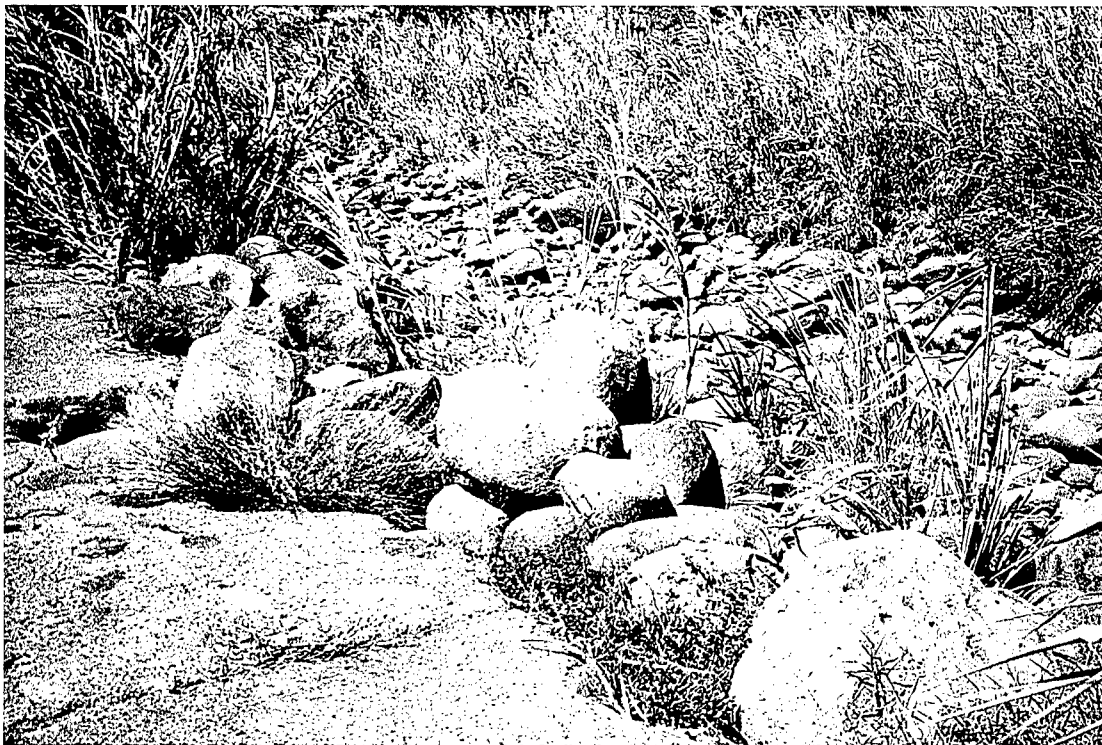
Photo 6. Repair to toe apron – Sta 41+00 to 49+00

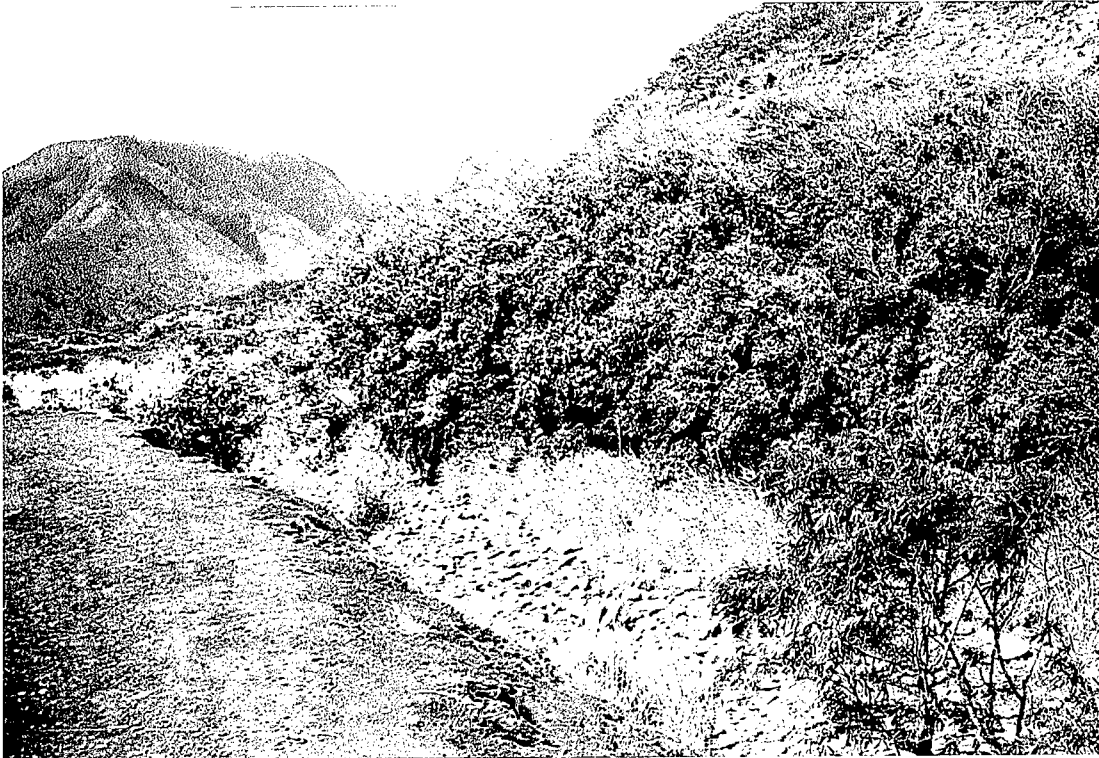
Photo 7. Constriction at Sta 40+00

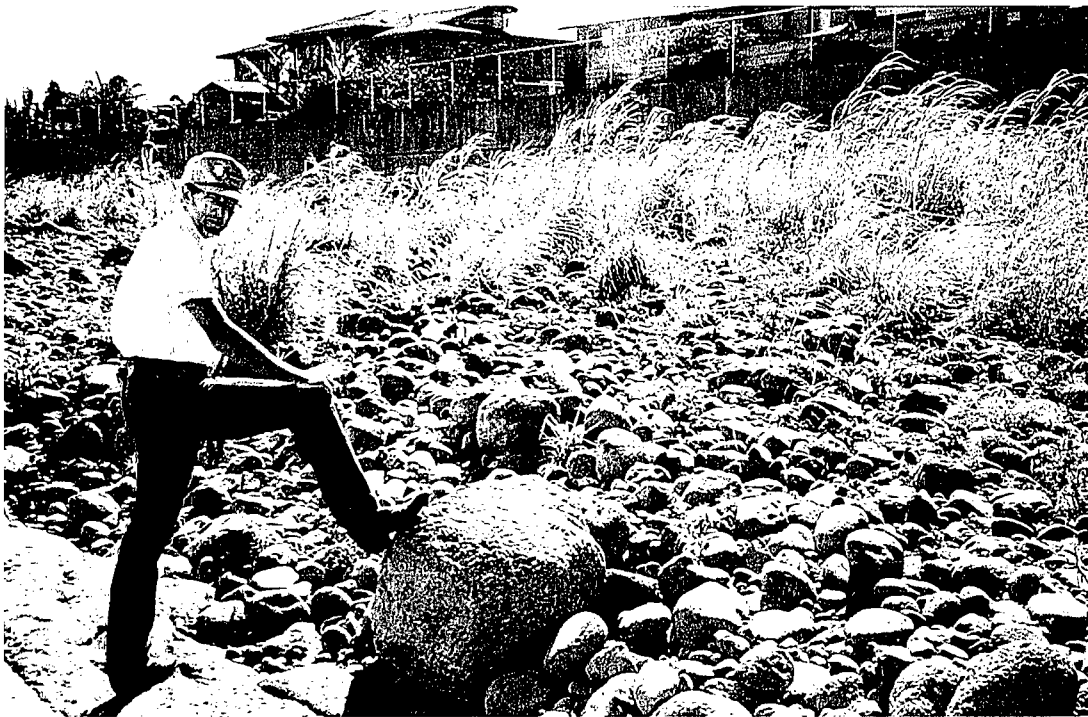
Photo 9. Deposition in boulder-concrete channel downstream from Waiehu Beach Road

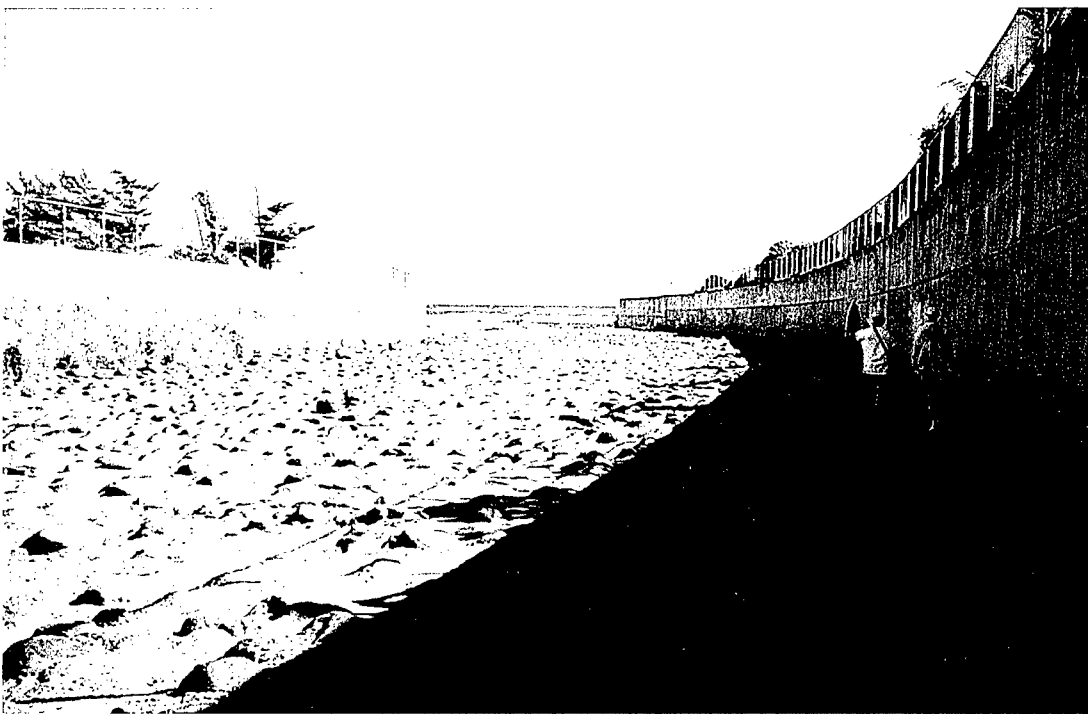
Photo 10. Downstream end of Iao Stream Project
